# NOAA Abandoned and Derelict Vessel Case Study

## F/V Santa Lucia

Contributor: Capt. David Dipre, Florida Fish and Wildlife Conservation Commission

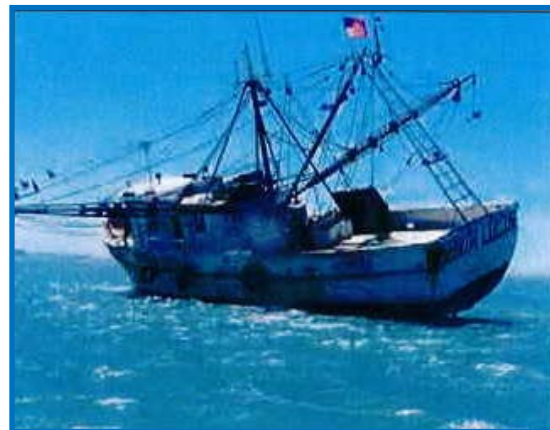
**General description of location:** Vessel was hard aground on a shoal on the northwest side of Calda Channel.

**History:** The vessel was heading to Stock Island Florida to avoid bad weather, she had pulled her shrimping gear and was headed in when the vessel lost her steering thus running aground. The vessel was so hard aground that it would require commercial salvage for removal. . The Captain admitted to being off course and claimed that the steering system malfunctioned, which ultimately led to the grounding. The Captain was not able to afford the removal operation and failure to remove the vessel caused it to be designated as abandoned and derelict. The vessel grounding caused considerable damage, including loss of oils and fuels into the environment, and seagrass scaring (approximately ½ mile long).

**Vessel removal summary:** Vessel and rigging removed and transferred to landfill and recycle facilities. Then the vessel was floated and towed into port. Approximately 74 tons of materials was disposed of.
