Summary Report and Lessons Learned

The Response to the Misawa Dock on the Washington Coast

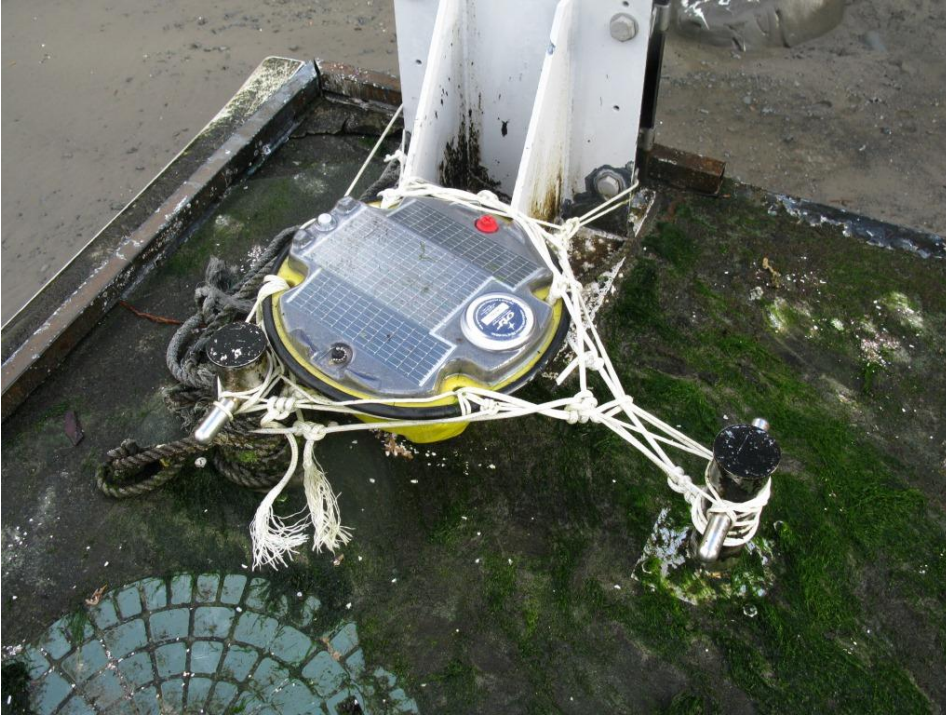
- **Tracking buoy:** The team secured and activated a tracking buoy to the dock's deck (Figure 8).
- **Aquatic Invasive Species:** The team assessed the abundance and distribution of AIS on the dock and collected numerous samples of organisms.
- **Radiation assessment:** Samples were taken from the dock to be analyzed for radiation.
- **Confirmation of dock origin:** The team looked for a plaque or other identifying markers on the dock, but was not able to find one. The team took photos of what appeared to be Japanese writing on dock parts. These photos were shared with the General Consulate of Japan in Seattle, and the Consulate initiated the confirmation process.

Figure 8: The tracking buoy is attached to the dock (Photo: WDFW)

In the first visit to the grounded dock, the team secured a NOAA tracking buoy to the deck of the dock and activated it. This was done to ensure that the location of the dock was known at all times, especially if it refloated, a remote possibility. The buoy transmitted GPS locations twice a day via email received by NOAA and several agencies.

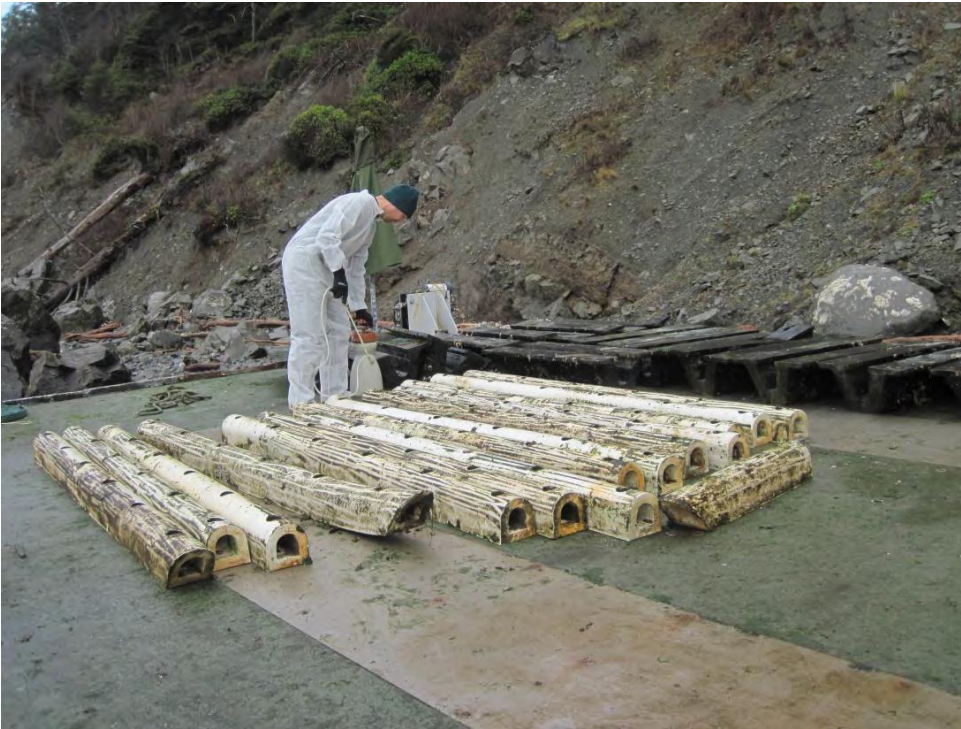
Figure 9: AIS cleanup. Judicious use of bleach on removed fenders and bumpers on Jan 3 (Photo: NPS)

On January 3 and 4, 2013, the team revisited the dock and cleaned the remaining growth from the dock. By then, even more growth had been stripped from the dock by surf action. Cleanup was done by scraping visible growth on the sides and deck of the dock, hauling 400 lbs. of biota up the bluff and away from water access, and sterilizing the surface with a bleach solution, used sparingly and under a permit from OCNMS. Vertical and horizontal bumpers, providing shelter to living organisms, were removed, cleaned, and stored in the hold of the dock (Figure 9). The team estimated that 99% of the visible growth had been removed, and additional AIS remediation efforts at this stage were no longer necessary.

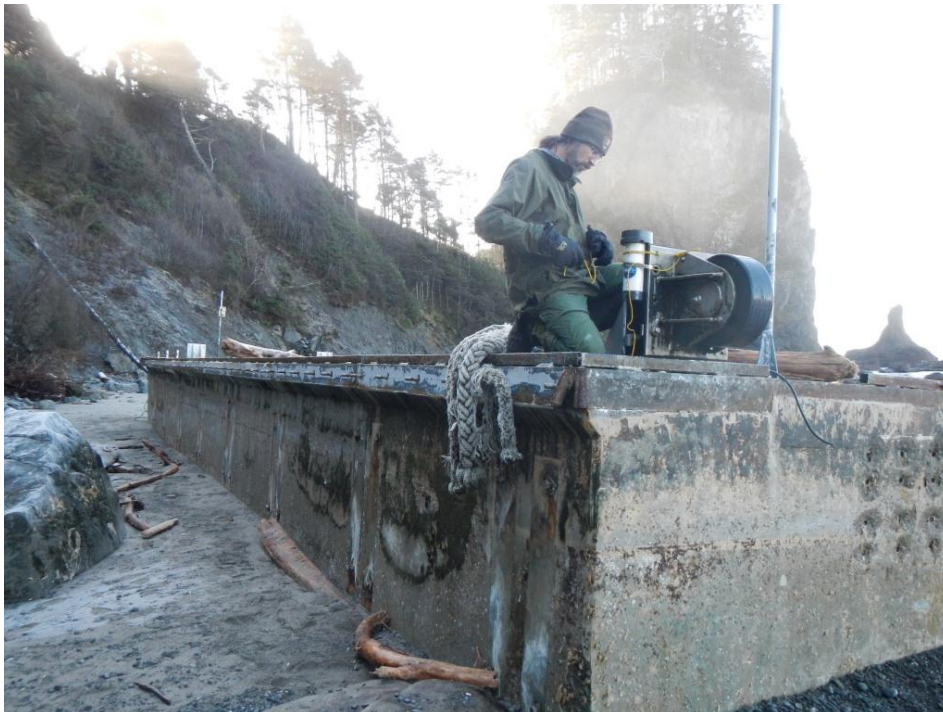
Figure 11: Repositioning the PMEL beacon on the dock on Jan 17 (Photo: NOAA)

After a few days, the charge of the solar-rechargeable batteries on the buoy was decreasing, and there was concern that the buoy would stop transmitting. Therefore, an additional beacon was secured from NOAA PMEL and attached to the dock on January 4 (Figure 11). Fortunately, both the tracking buoy and the PMEL beacon continued to transmit daily, and for several weeks, all involved entities were updated daily on the location of the dock, which remained essentially the same (Figure 12).

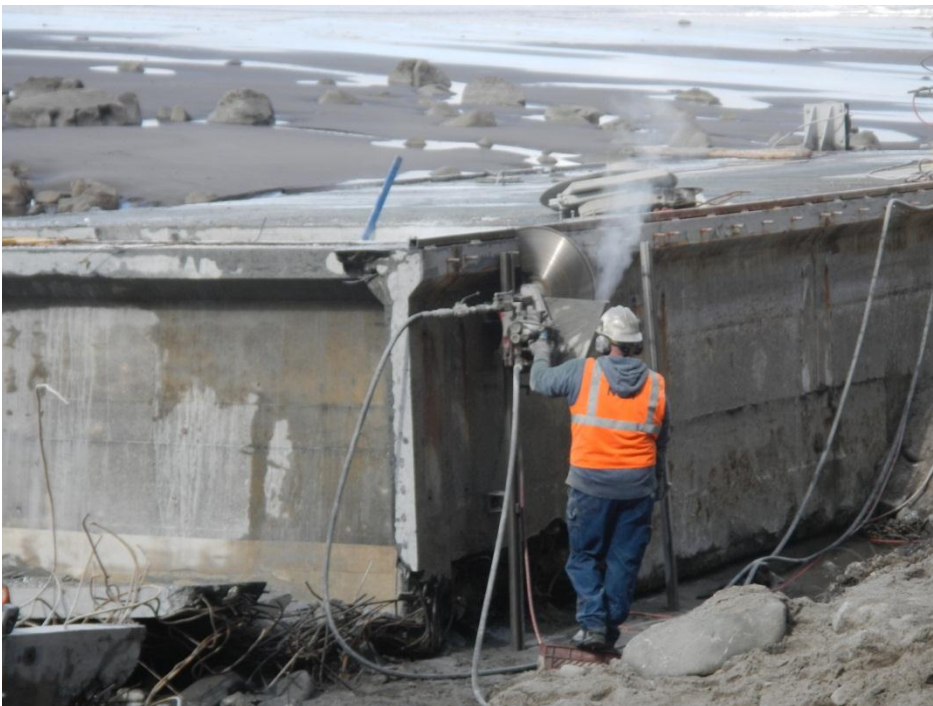
Figure 14: Cutting the dock with a concrete circular saw (Photo: NOAA)

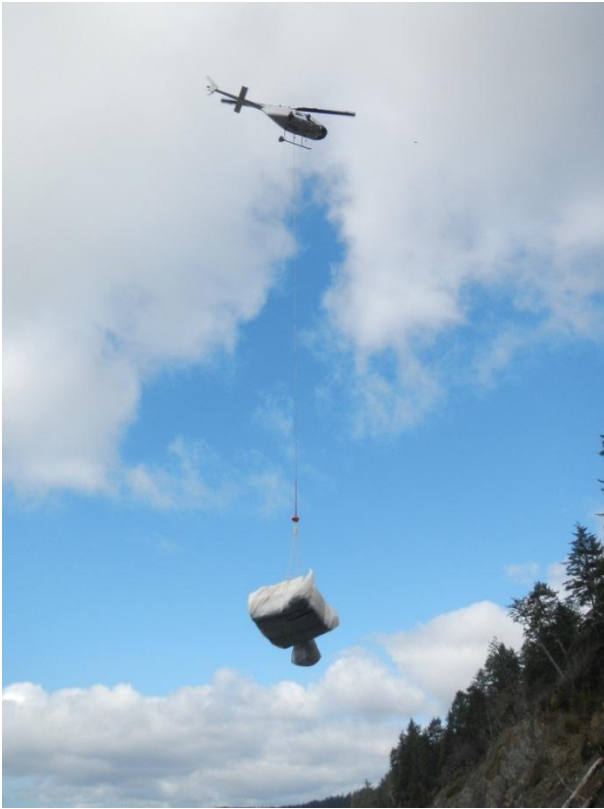
Figure 15: Removal of foamed plastic with the Jet Ranger (Photo: NOAA)

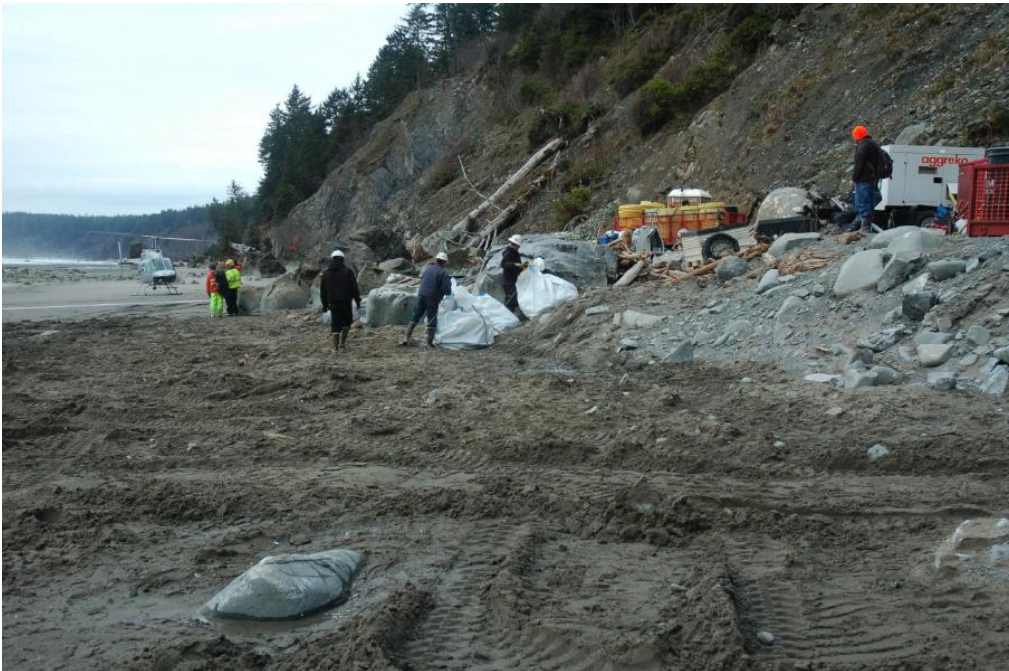
Figure 16: Site cleanup after dock removal is completed (Photo: The Undersea Company)
